## **ROLE OF WEAK SOILS AND RELICT GEOLOGICAL DISCONTINUITIES IN CREEPING SLOPE FAILURE AT POOLIYADDA, SRI LANKA.**

**UDENI B. AMARASINGHE<sup>a\*</sup>, KAPILA DAHANAYAKE<sup>a</sup> AND NIMAL SENEVIRATNE<sup>b</sup>**

### **ABSTRACT**

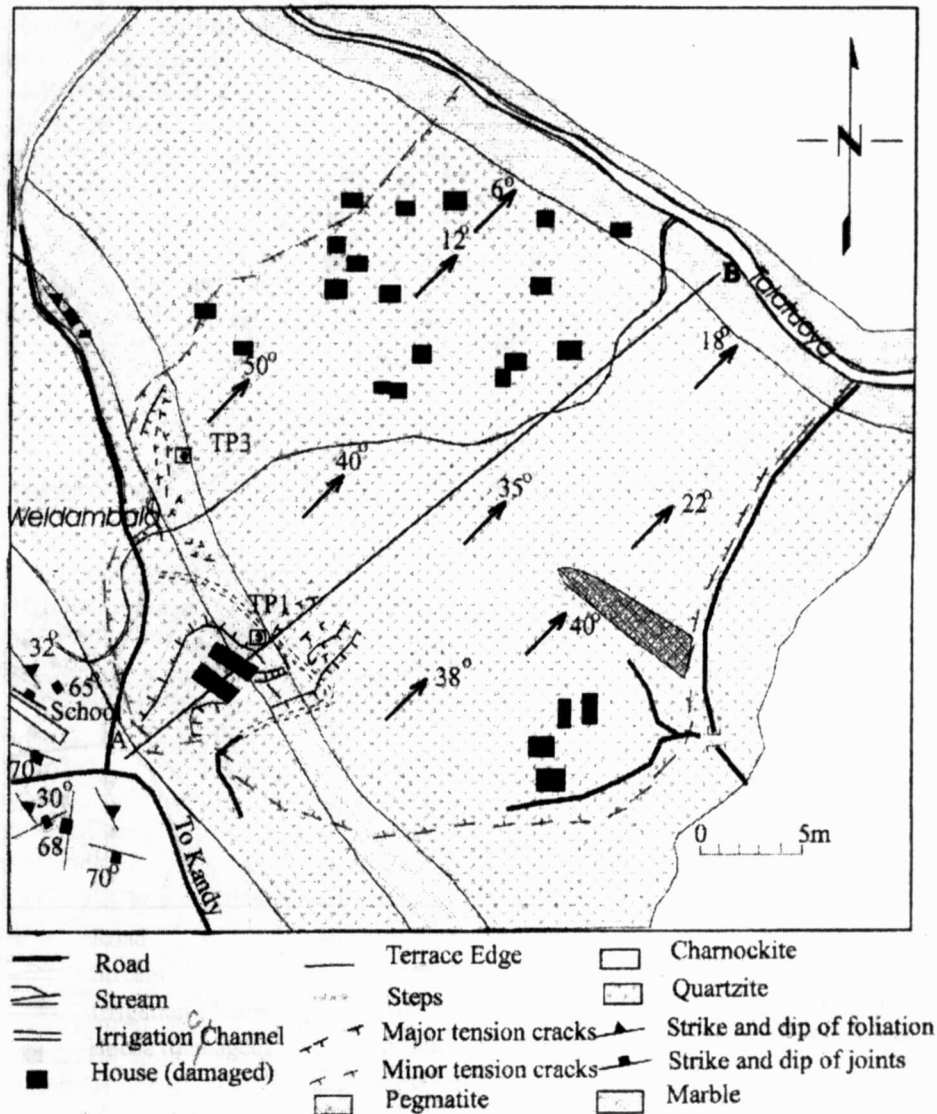
Perched water table from 3.0m depth

Fig.2 Engineering Geological Map of the Study Area

The detailed engineering geological map, Fig 2 shows that the Pooliyadda creeping slope failure occurred in the soils of a weathering profile. The weathering profile has developed on the bed rock mass over a long period of time (Fig. 4). As this is a dip slope type failure, rock bands are parallel to the slope, the slope cover is the weathering product of the upper lithologic layer, quartzite bed rock. The two lower soil layers- the pinkish to whitish inorganic silt (MH) layer and whitish to greenish inorganic silt (MH) layer are found to be the weathering products of the lower lying conformable pegmatite rock layer in the bed rock mass. The parent quartzite rock appears to contain a greater quantity of coarse grained quartz minerals, with feldspar and iron oxides as accessory amounts. The clayey sand layer (SC) has evolved as a result of decomposition of feldspar and iron oxides together with the residue of quartz grains of sand and gravel sizes. As a coarse grained soil the upper layer (SC) has developed to become a highly permeable layer, which could have influenced the faster infiltration of water during the rainy period.

As shown in Fig. 2 a perched water table was found to exist at a depth 2.5 to 3.0 m below the surface. The fast infiltrating water from the surface tends to saturate the slip surface materials. As a result shear failure occurs in the slip surface soil layers, the upper pinkish to white layer and the lower whitish to greenish layer. It is clear that under saturated condition very low shear strengths can be attained by the slip surface silty material. Direct shear test results obtained in saturated condition supported this fact as indicated in the Figs.7, 8 and 9.

Figure 2 shows the structural joint discontinuities of the bed rock mass. The two main joint sets are visible in the 1C horizon/ completely weathered rock as faintly developed stained and secondary mineral

filled relict discontinuities. The study shows that the relict discontinuity planes controlled the development of tension cracks as well as the surfaces of the head scarp and the lateral scarp.

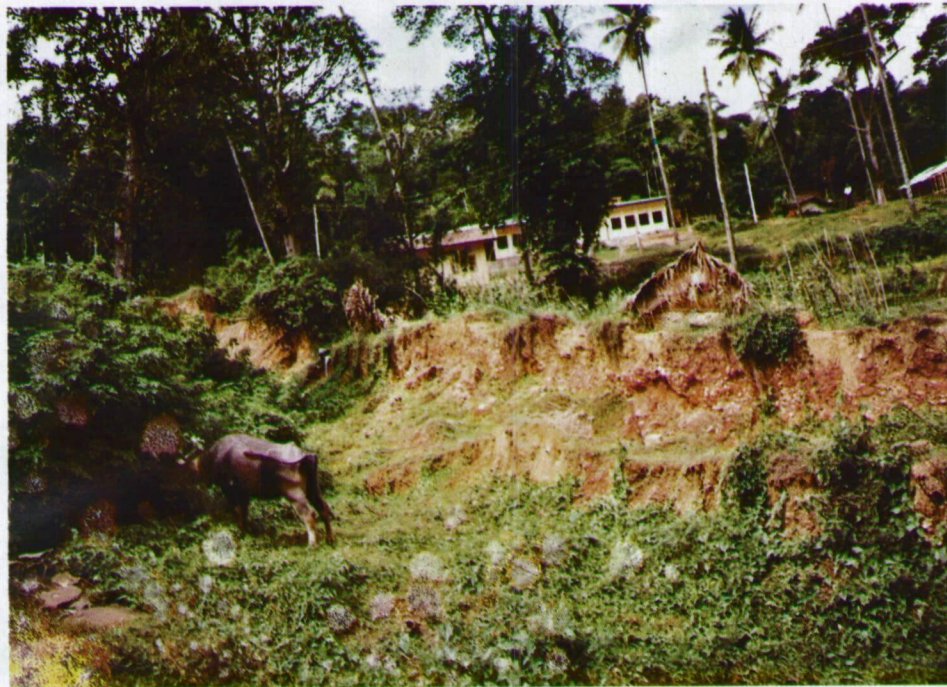
As shown in the Figs 2 and 3 Pooliyadda slope failure occurred on an area underlying two school buildings and about 40 houses in 1996. Land subsidence occurred due to a slow creeping vertical downward movement of 6m observed on the scarp surface of the slide (Fig.3). The slope is underlain by an upper layer of highly weathered quartzite associated with a lower lying conformable layer of completely weathered pegmatite. Both these layers are characterized by the presence of relict mineral bands. The weathered quartzite rock shows gravel size quartz bands in a reddish silty clay medium and the weathered pegmatite shows whitish secondary kaolin type clay mineral material together with greenish chlorite mica formed due to chemical weathering of primary minerals such as feldspar and biotite. This soil layer is the 1C horizon of a typical weathering profile and it is recognized by evidence of the "saprolite" original rock structure in the soil material. It is significant to note that relict residual shear planes were observed in the completely

Fig. 3 Pooliyadda Creeping Slope Failure with Damaged Buildings of Weldambala School in the background.

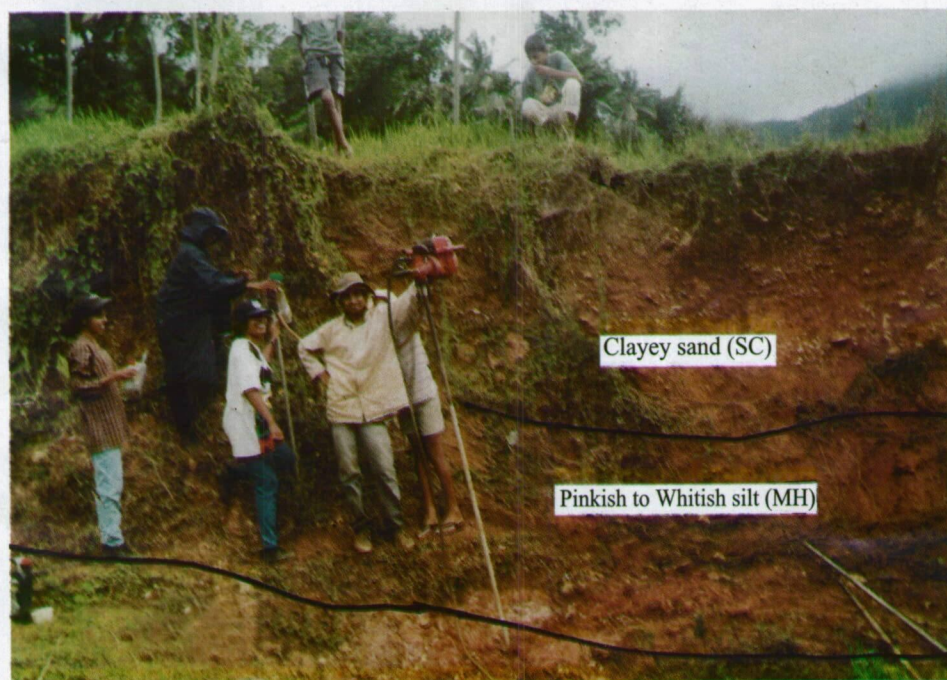
weathered pegmatitic parent rock. The strike and dip of rock foliation is found to be  $35^\circ$  NW and  $32^\circ$  NE respectively. Figs. 4, 5, and, 6 show the cross section of the rock weathering profile. The upper layer is found to be highly permeable clayey sand with gravel (SC). The second layer from the surface is a pinkish to white clayey silt (MH) and the third layer is the whitish to greenish clayey silt (MH) layer (Fig.4). These silty layers are composed of kaolin clay and

Fig. 4 Weathering Profile at the head scarp of the slope failure.

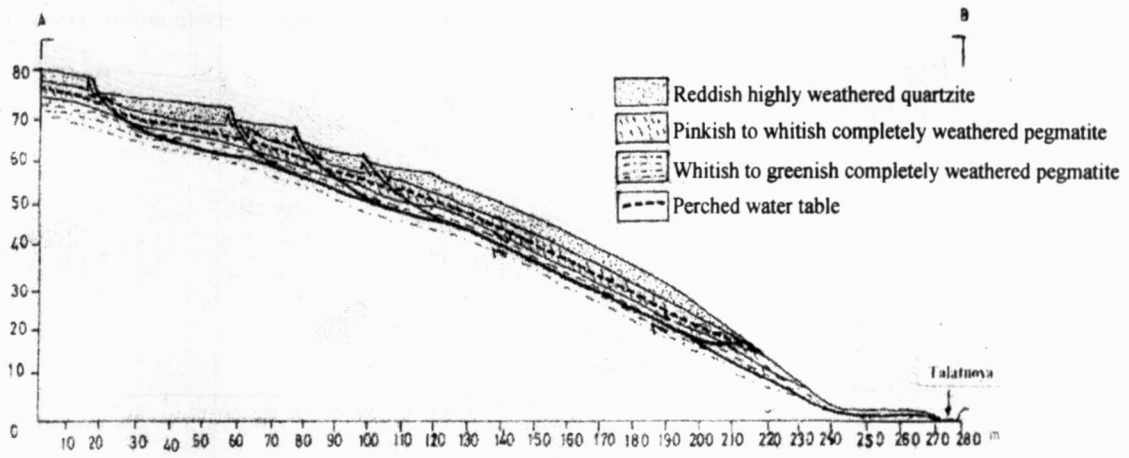
Fig. 5 A Longitudinal Section Between Points A and B as indicated in Fig.2.

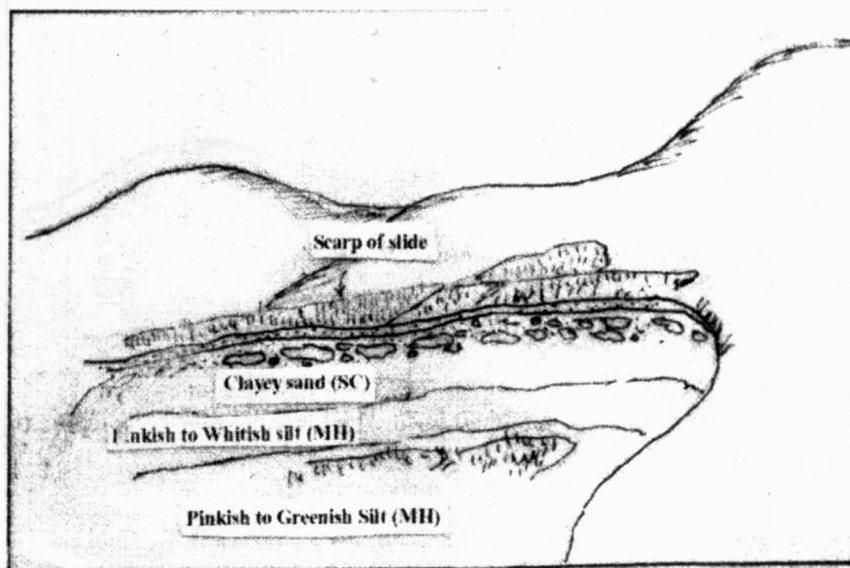
Fig. 6 A Schematic Soil Profile at the Scarp of the Slide

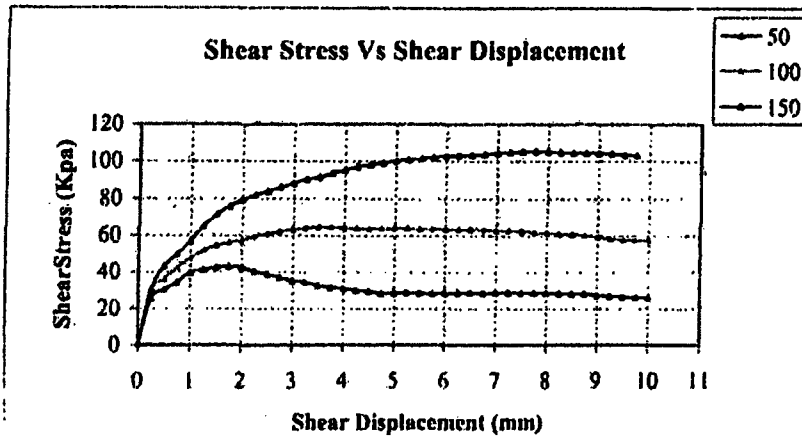
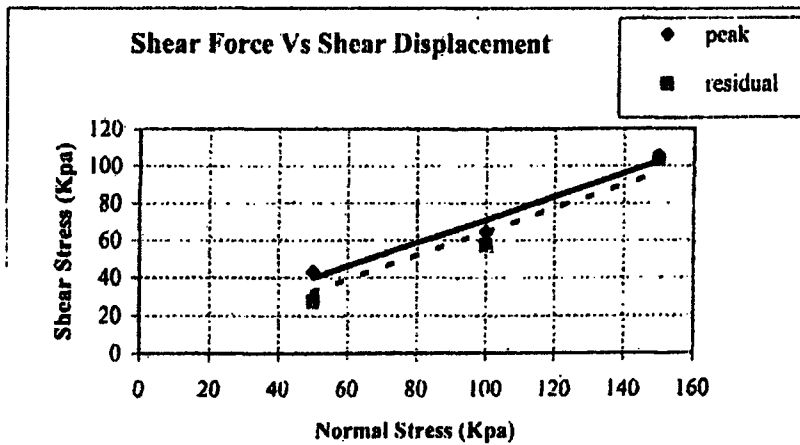
Figures 7,8, and 9 show direct shear test results and the angle of friction values of the slip surface soil material. The angle of friction  $\phi$  values of the slip

surface materials is found to range between 23.3° and 32°. The cohesion component found to vary between 0 and 11 KPa.

Peak Shear Properties	Residual Shear Properties
Equation	$y = 0.625x + 8.3$ $R^2 = 0.9686$	$y = 0.628x$ $R^2 = 0.9861$
Cohesion	8.3	0
Friction	32	32

Fig. 7 Direct Shear Test Results of the Whitish to Greenish Slip Surface material (TP1 in Fig.2)

It is also important to understand the engineering characteristics of the weak soil material in which the slip surface of the slide had developed. Shear strength parameters ( $\phi$ ,  $c$ ) of the slip surface weak materials are shown in the Fig. 7, Fig. 8, and Fig. 9. Direct shear test was carried out on undisturbed box samples carefully taken from the slip surface area from three test pits and exposures. The upper fine grained soil layer (MH) and the lower layer (MH) have been sheared by the slope failure as evidenced in the test pits and the scarp exposures. Tests were run in saturated condition as the real slope failure also takes place in that condition under the perched water table. The friction angle  $\phi$  and the cohesive component ' $c$ ' of the shear strength property of these soils indicate that very weak soils have developed in the weathering profile to form the slip surface. The friction angle  $\phi$  which ranges from  $23.3^{\circ}$  to  $32^{\circ}$ , is due to local variations of chlorite mica and unweathered feldspar content (XRD pattern in Fig.11 shows presence of feldspar) and small amounts of quartz sand grains constituted in the slip surface materials. The cohesion = 0 and low amounts indicate that silt size kaolin mineral particles with mica flakes in the slip surface material had reduced this value. The grain size distribution curves shown in the Fig.10 indicate that the slip surface material consisted mainly of particles of silt size but not clay size. This is found to be the cause of very lower cohesive strength component as a shear strength parameter of the slip surface material.

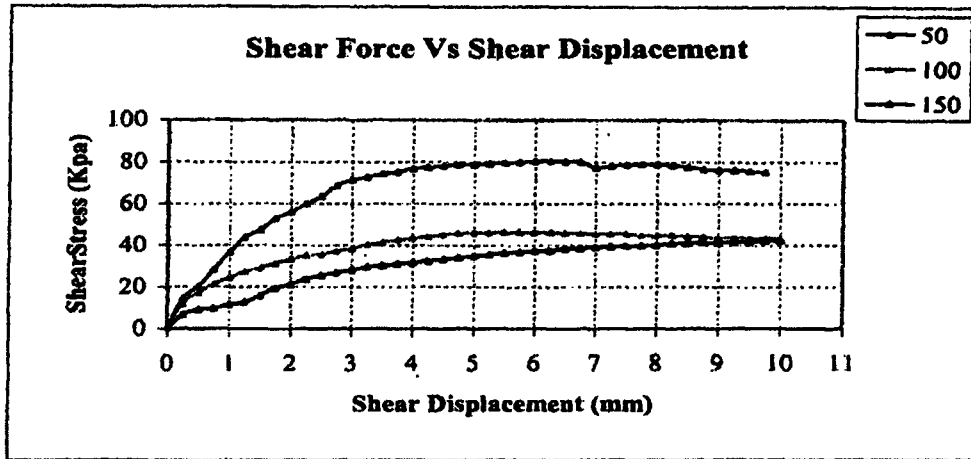
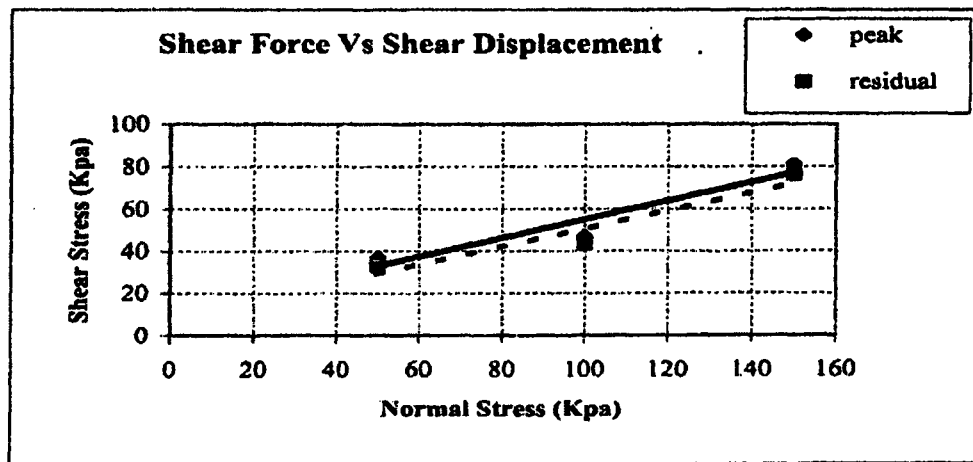
Peak Shear Properties	Residual Shear Properties
Equation	$y = 0.44x + 11$ $R^2 = 0.9098$	$y = 0.43x + 6.8667$ $R^2 = 0.9129$
Cohesion	11	6
Friction	23.7	23.3

Fig. 8 Direct Shear Test Results of the Whitish to Pinkish Slip Surface Material (TP2 in Fig.2)

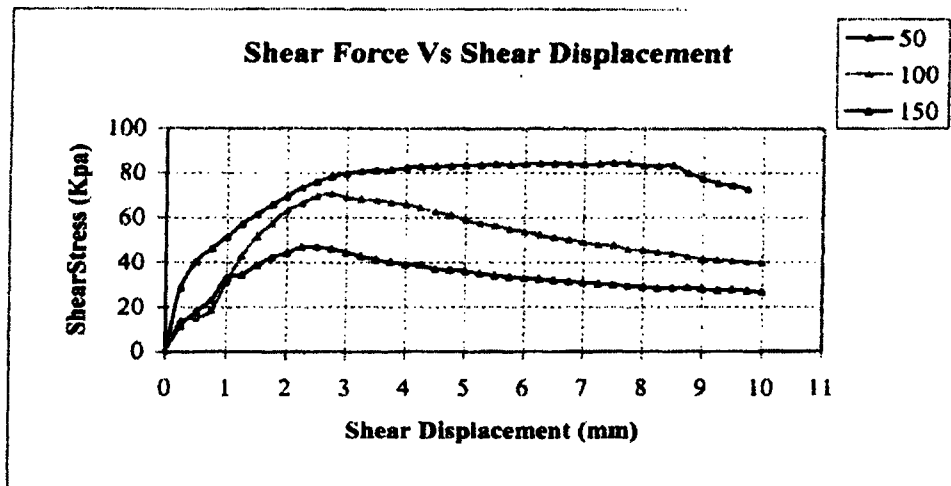
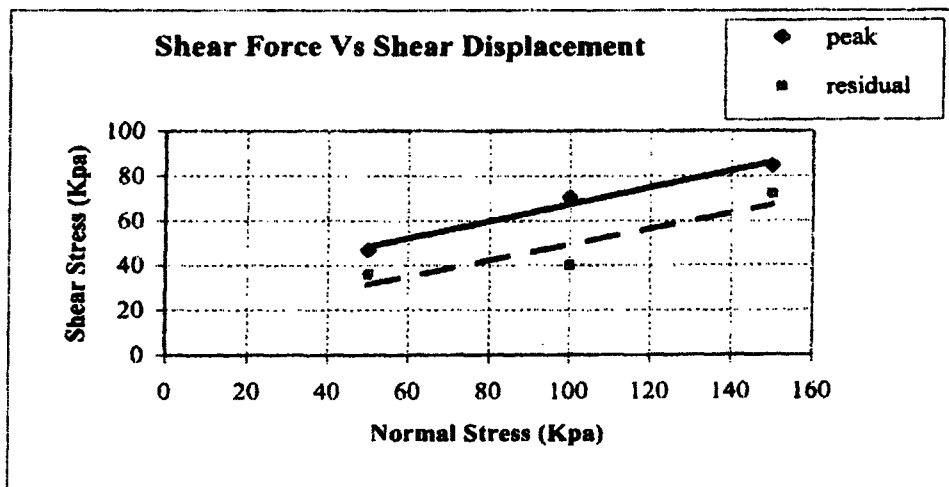
Peak Shear Properties	Residual Shear Properties
Equation	$y = 0.378x + 29.4$ $R^2 = 0.979$	$y = 0.36x + 13.333$ $R^2 = 0.8922$
Cohesion	29	13
Friction	20.7	19.7

Fig. 9 Direct Shear Test Results of the Pinkish Slip Surface Material (TP3 in Fig.3)

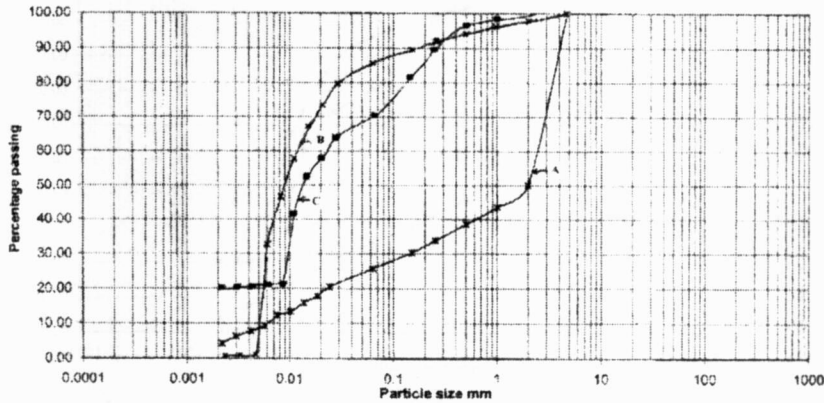
Figure 10 shows the grain size distribution of the three soil layers from the surface A, B, and C in that order. The soil layer is classified as clayey sands and sand clay mixture (SC) according to the Unified Soil Classification scheme [6]. The completely weathered pegmatite rock serves as the slip surface material and

there are two upper and lower layers. The upper layer is pinkish to whitish and is classified as inorganic silts (MH) and the lower layer is whitish to greenish and is classified as inorganic silt (MH). The upper slip surface material shows plastic limit (41%), liquid limit (95%) while the lower slip surface material shows plastic limit (30%) and liquid limit (51%).

Fig. 10 Grain Size Distribution Curves of Three Soil Layers (A,B,C) from Top to Bottom of the Soil Profile

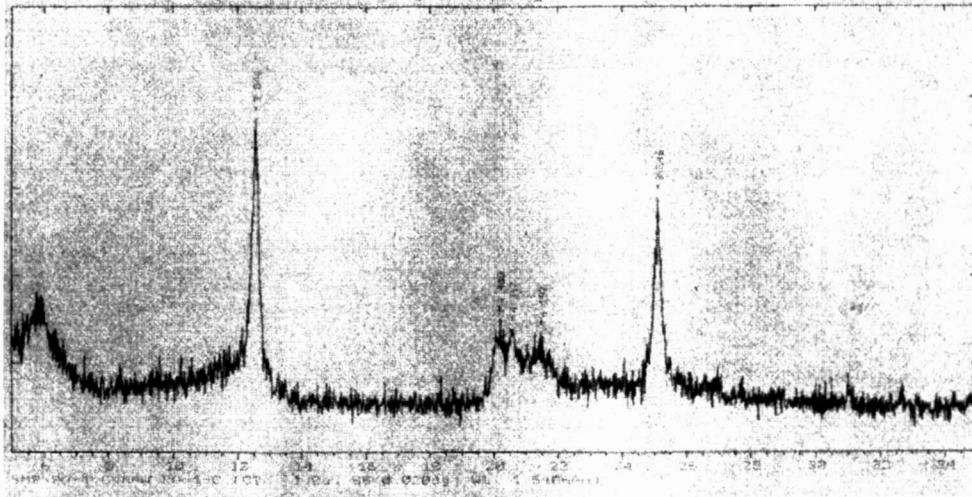
Fig. 11 The X-ray Diffraction Pattern of the Slip Surface Material (MH) shown in Fig. 4

Figure 11 shows X-ray diffraction (XRD) diagrams and the fine fraction of the soil layers is found to be rich in kaolin clay mineral particles as indicated by the 'd-value' of 7.044. The slip surface material also contains unweathered primary minerals in the form of microcline feldspar as indicated by 'd-value' (4.137) together with gibbsite by d-value (4.317), goethite by 'd-value' (4.40) and quartz with 'd-value' (3.456) (according to ASTM card index in Muller [7]).

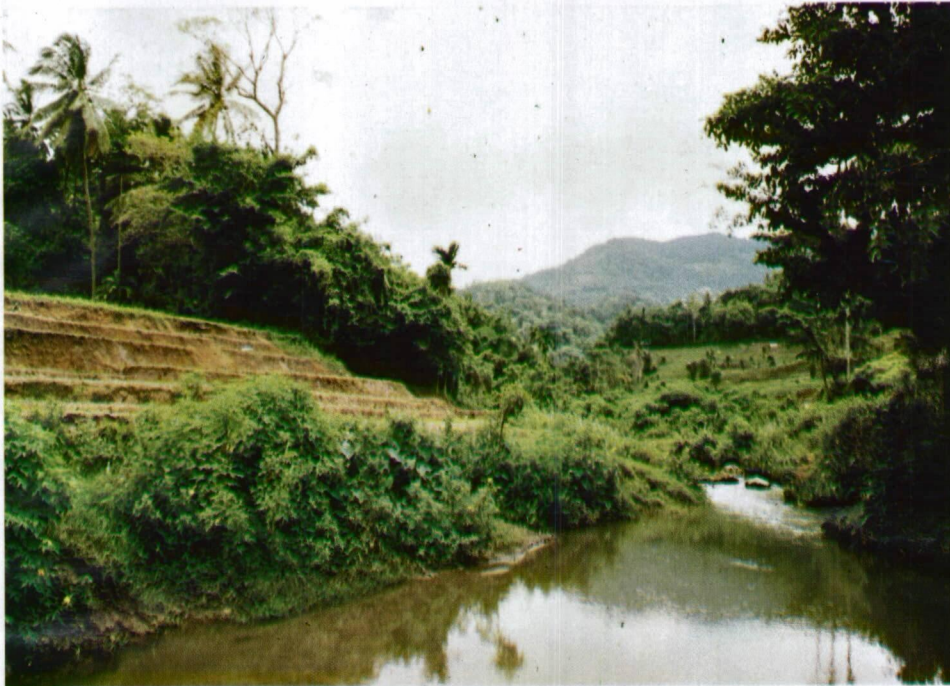
Fig. 12 Toe of the landslide (left) buttressed against Talatuoya stream flowing along a marble band. Some of the toe materials appear to have been absorbed into sink holes developed within this band

When land subsidence was observed close to the crest and head scarp area, an upheaval is observed in the middle and lower parts of the creeping mass. The newly developed tension crack pattern indicates that the movement had taken place in stages along three slip surfaces giving rise to three benches on the slope. It also appears that karstic marble existing close to toe area possesses solution cavities, which probably absorbed the flowing debris of the slide and prevented damaging of the Talatuoya stream as shown in the Fig.12.
