LANDSLIDES IN SRI LANKA : SOME ASPECTS

JINADASA KATUPOTHA

*Department of Geography,
University of Sri Jayewardenepura.*

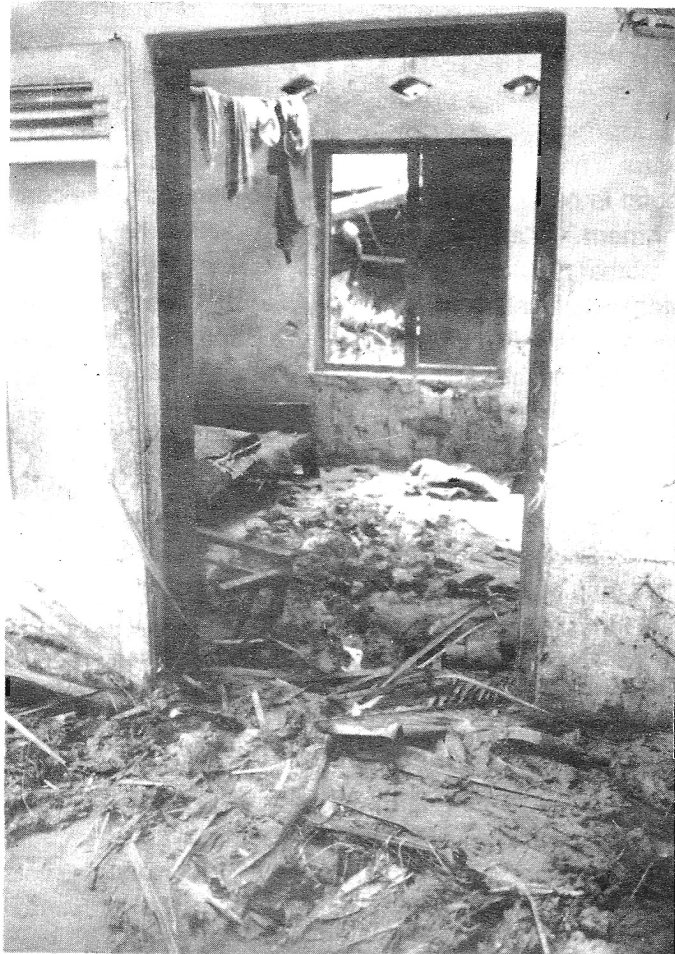
Plate 4: (A) Damaged rooms in one of the houses shown in Plate 3 (B). (B) rock and other debris of the same landslide of Plate 3.
