# CONSERVATION OF

## ABHAYAGIRI STUPA

### AT ANURADHAPURA

**ARCHT. LALITH MUTUKUMARANA**  
**DIRECTOR – CONSERVATION, ABHAYAGIRI PROJECT**

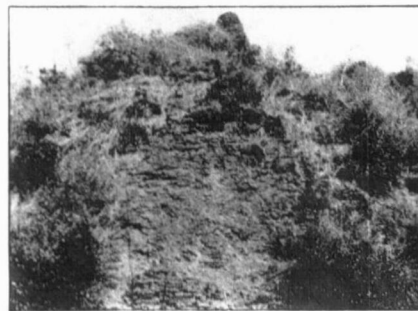
- I The hard wood tress like **Ebony** and **Margosa** have developed strong roots that have penetrated several brick courses to the interior of the structure. The growth of these roots have caused outward swelling of the brick courses thereby loosening the bond, and subjecting the structure to gradual erosion. On the other hand the surface network of roots have also helped to stabilise the

bricks against erosion. These opposing effects of vegetation on the brick structure coupled with weather erosion and animal destruction has resulted in a ruined state potted with protrusions and depressions throughout its surface, as shown in photograph 04 one interesting feature observed in the nature of plant growth on the stupa is somewhat dwarf growth of normally tall tress due to constricted growth, as followed in the Bonsai technique.

- II. The ancient outer plaster is seen exposed at several places, where the brick bond and the bricks are in an excellent state of preservation.

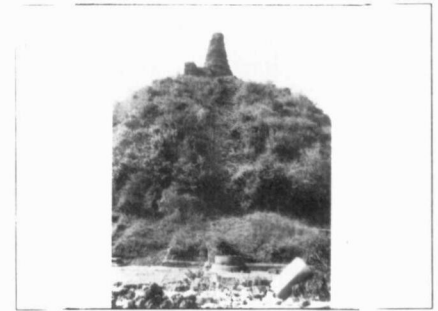
- IV. The outer surface comprises stretcher courses finely bonded together with minimum mortar joints which are of the order of 1/16" and less. Some layers appear almost sitting one on top of the other. The interior is finely bonded with headers and stretchers.

The average compression strength = 10.00 Newtons/MM<sup>2</sup> of ancient bricks at Abhayagiri

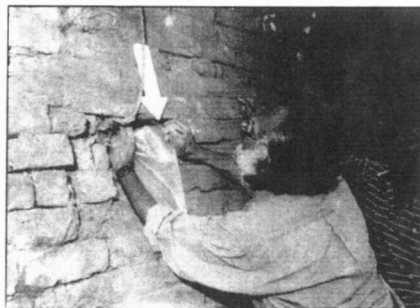
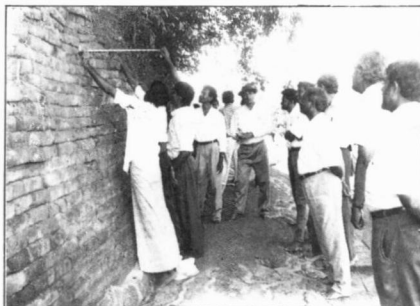
The ancient Stupa it appears had used Butter Clay with perhaps some organic adhesives for bonding the bricks. These additives are now untraceable as they have been reduced to carbon over the years. No cement had been used. **Thus the text mixture No. 2 without cement has been selected for use on a further experimental band on the Stupa. As the injection of a mortar is intended to stabilize the surface layers, a strength of 3/N/MM<sup>2</sup> is considered adequate and satisfactory for the purpose.**

The following technique has now been decided for use in the brick conservation of Stupa.

The final experiment on the conservation of brick structure of the Stupa Dome carried out on 9th August 1996 using Ant-Hill Clay, Lime, Paddy Husk Ash, Tile Powder and Water in the proportions given above has shown excellent results. After 28 days the masonry bond appeared strong and free of cracks. Minimal shrinkage was observed, and the colour of the mortar too matched the ancient brick surface. The conserved brick surface has stayed strong and solid after several wash down by rain and manual wetting. The behaviour of the conserved patch is being carefully monitored on a day to day basis with constant wetting daily. In the meantime a larger portion is now being prepared for conservation using the above technique.

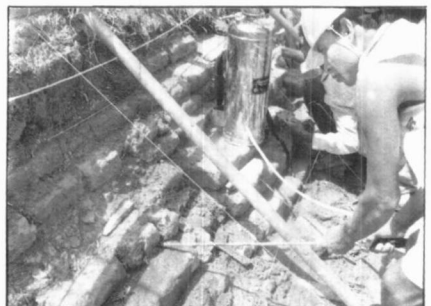
- Step v. Fine pointing the mortar joints with a pointing trowel using the above mixture. (see Photographs 11).

- Step ii. Cleaning the exposed brick surface carefully of debris and soil by finely brushing down to expose the brick courses.

- Step iii. Cleaning the brick courses by directing a pressurized water jet (Pesticide Sprayer is used here) at the mortar joints to clear decayed and loose mortar to a depth of about 1 foot (care being exercised not to break loose strongly bonded brick work).

- Step iv. Using improvised Injector Gun (specially designed for this purpose modifying a Grease Gun) injecting a mortar slurry of Lime, Ant-Hill Clay, Tile Powder, Paddy Husk Ash and Water (special care being exercised not to spill the slurry over the brick face).
