CHANGING COASTLINE
OF
SOUTHWEST SRI LANKA

Upali Weerakkody

2018

Published by Natural Resources, Energy & Science
Authority of Sri Lanka.
No 47/5, Maitland Place,
Colombo.

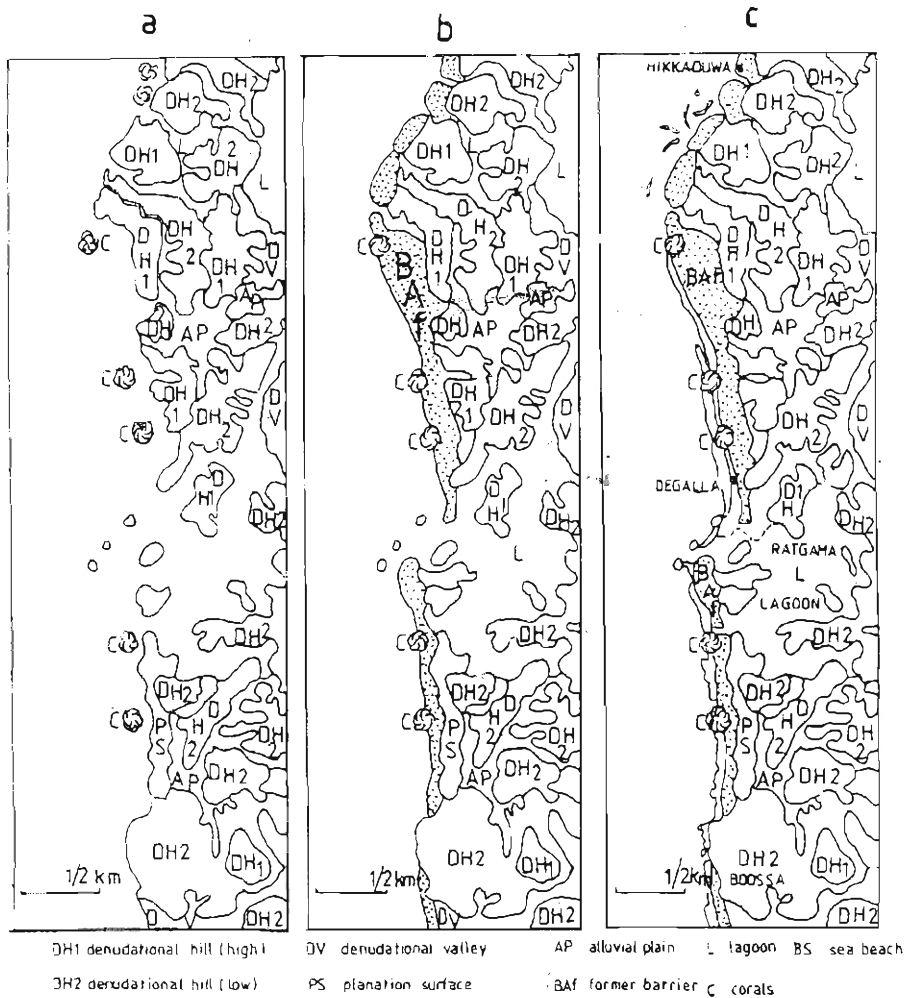
Figure 3.1.2- The phases of the coastal evolution along the Hikkaduwa-Boossa tract. The rise of the sea level has submerged the entire area to form a cliff coast and a baylet. Some parts of the offshore area were occupied by coral reefs. (a). When the sea level gradually dropped during the second phase, the barrier chains developed in front of the cliff coast (b). The third phase is characterized by wide sea beaches (c).

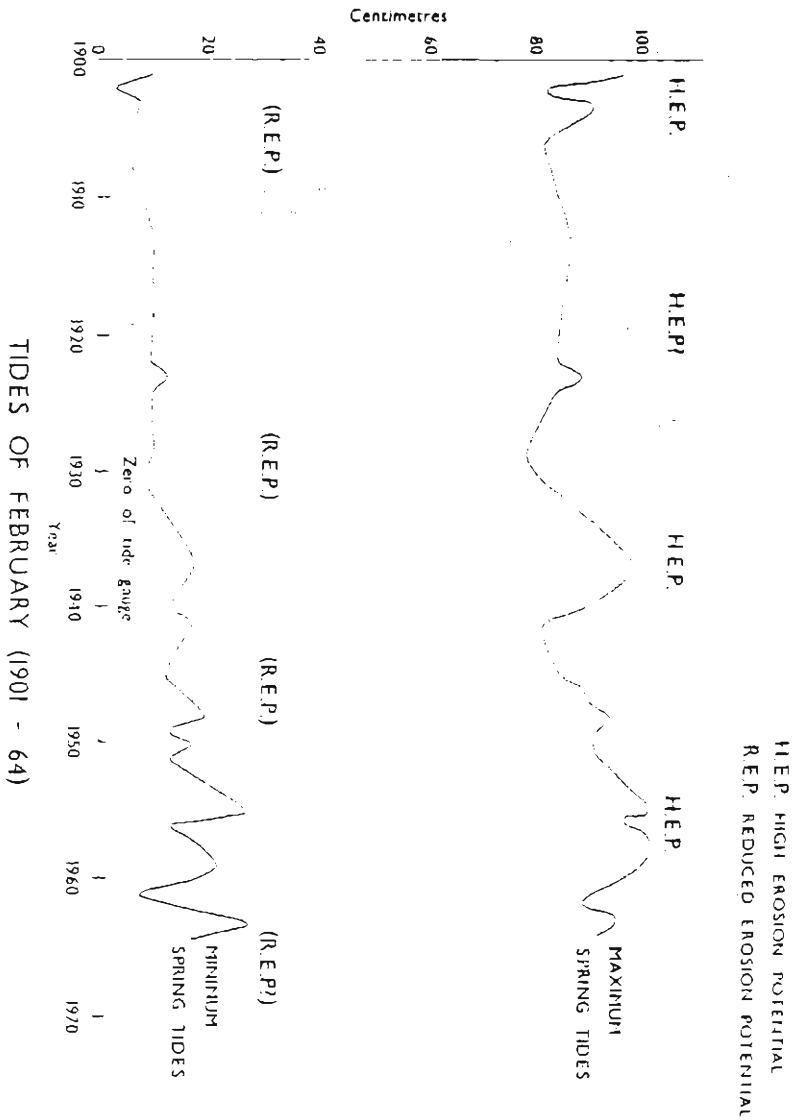
Figure 3.1.3- Available data suggest that tidal cycles occur. Period of higher tides are associated with potentially greater erosion. Source: Swan (1974, p24).

The fluctuations of the sea level during the Quaternary have submerged the coastal zone of SW Sri Lanka. Ancient marine landforms reworked by marine action in the immediate hinterland are the result of the last maximum rise and subsequent fall of sea level since the mid-Holocene time. The Hikkaduwa lagoonal plain, for example, exhibits varying degrees of submergence and sequential landforms, while the Ratgama-Boossa area is characterized by denudational hills and planation surfaces: (Figure 3.1.2). Figure 3.1.1 shows that the sea level along the Sri Lankan coasts has gradually dropped until 2500 BP (1000 BC) and hereafter no data is available. A slight rise of sea level was observed during the last century in Sri Lanka (Figure 3.1.3).

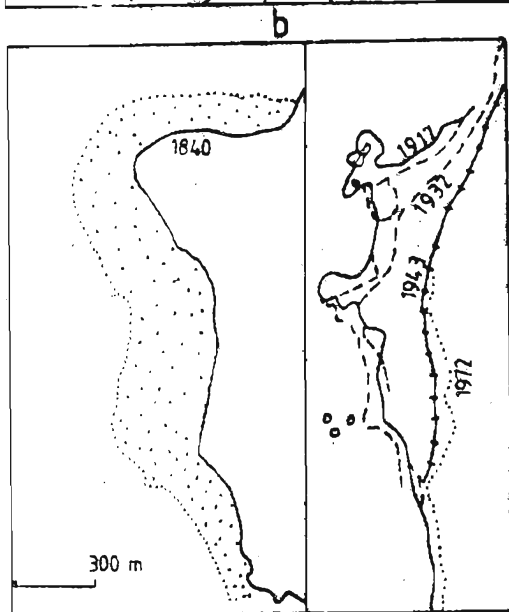
Figure 4.1.3- Diagram drawn by Dassanayake (1928) illustrating beach erosion and accretion as observed near 60 th mile, Colombo-Galle road (or compartment 4.1) during the period 1915-21 (a). The coastline changes of Seenigama since 1840 shown by (b) unravel that a huge land portion has disappeared during the last century. Orientation of the diagram (a) was readjusted by the author. Diagram (b) was taken from Weerakkody (1983).

Changes of the processes also included changing longshore currents in the study area during the first decades of the 20 th century. This is evident, for instance from the changes that took place along the Seenigama coast. Before 1840, the Seenigama coastline was protected by a large headland with a wide sandy beach. The southern part was demarcated by the Hikkaduwa Ganga outfall. Northward sand bearing longshore currents were introduced at the Seenigama cape. The existing sandy beaches and some parts of the barriers near the cape were removed and their materials redeposited at the northern end of the coast. As revealed on the one-inch map of 1917, the northern and southern parts of the headland were eroded. It could be believed that erosional processes were intensified between 1915 and 1921. This situation has been well documented by Dassanayake (1928), a pioneer coastal engineer of Sri Lanka (Figure 4.1.3 a & b).

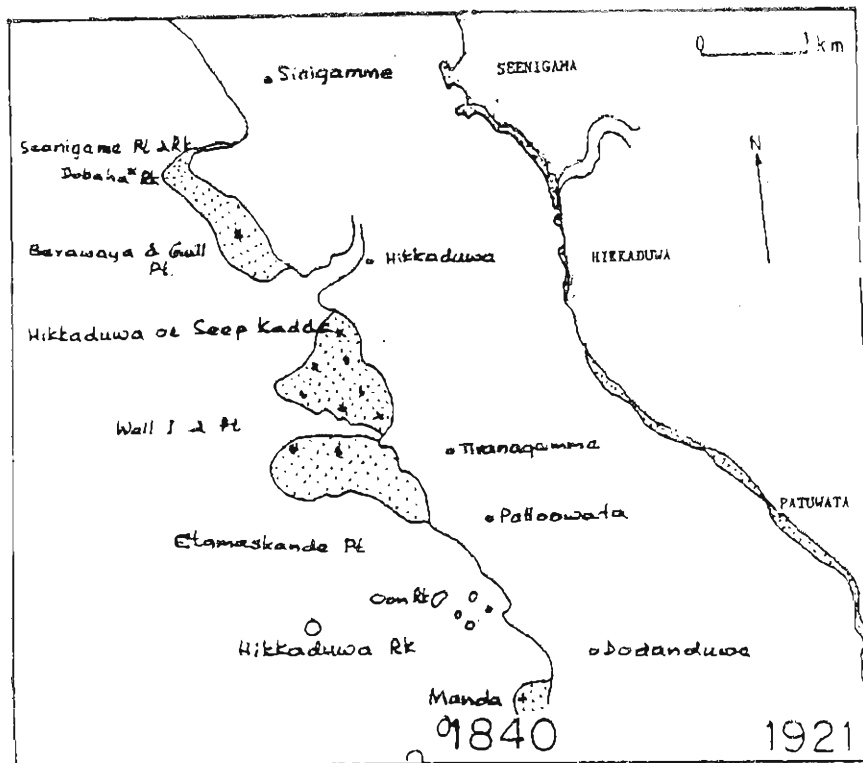
Figure 4.1.4- The landforms of the Seenigama-Dodanduwa coast in 1840 and 1921. The coast mapped in 1840 by John Fraser, shows large land portions projected seaward. The dotted areas apparently are wide beaches while the asterisks indicate emerged ledges.

The changes that have taken place in the Hikkaduwa Ganga outfall and the Dodanduwa coasts are shown in Figure 4.1.4. During the early decades of the 19th century, the northern and southern parts of the Hikkaduwa Ganga outfall were rich in extensive sandy beaches as well as hinterlands. During the late 1880's, these landforms were destroyed and the outfall was barricaded by a sand spit. Between 1934 and 1943, the southern portion of the spit was eroded. Subsequently, the sand spit was also destroyed. Now the coastline with the outfall appears as a complex field of groynes and revetments connected to each other.

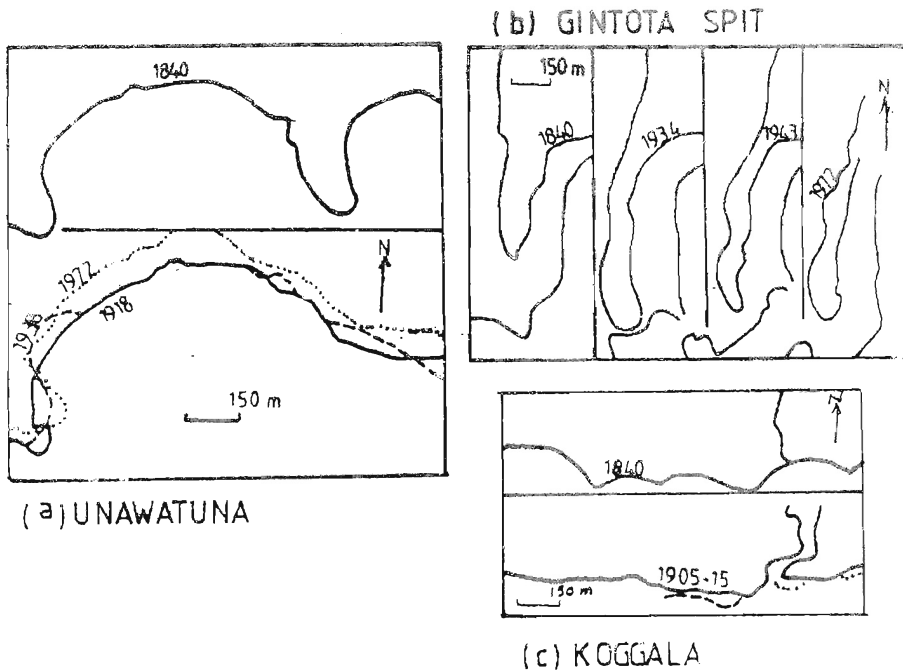
Figure 4.1.5- The Unawatuna coast of 1840 was a baylet protected by two headlands. As shown by the topographical map of 1918, the eastern headland was destroyed(a). The Gin River mouth is occupied by a sand spit which has changed its length and width during the period between 1840 and 1972 (b). However, the map of 1840 does not show the present small spit in front of the Koggala lagoonal outfall. It first appeared in the map of 1905-15 (c).

As shown by the first topographical map of 1918 of the area, the headland was completely destroyed. Nowadays, its ruins can be observed offshore. The ultimate result of the changes is the conversion of the baylet into a log-spiral shaped coastline (Figure 4.1.5 a).

The most important feature of the river mouths and outfalls is the growth of spits during historical time. The largest among the smallest sand spits that developed during historical times is the elongated sand spit in front of the Gin River mouth. This first appeared in the map of 1660 (Figure 4.1.2). The spit changed considerably during the last century (Figure 4.1.5b).

A small spit developed in the same period in front of the Koggala lagoonal outfall and still persists notwithstanding considerable changes (Figure 4.1.5 c). At present, many lagoonal outfalls of the SW coast are protected by two parallel groynes preventing the formation of barrier spits in front of them as can be observed at Hikkaduwa, Madampe, Goyyapana, etc.

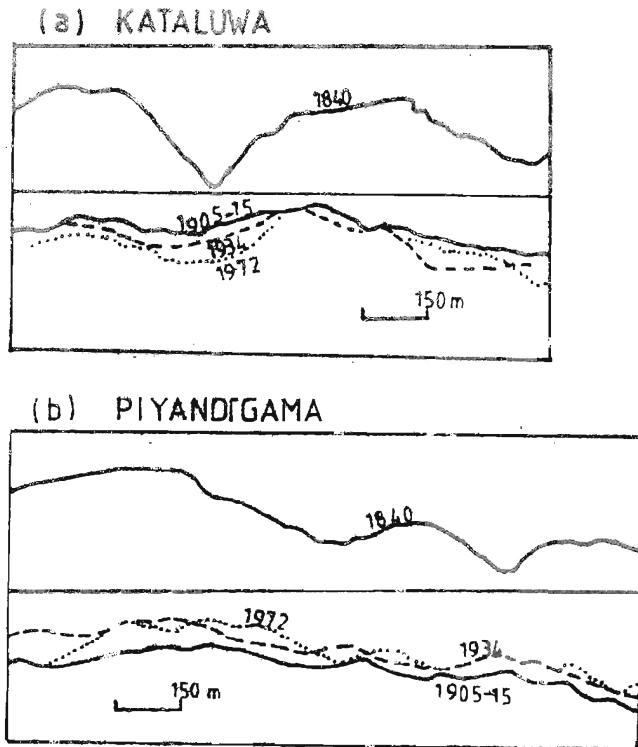
Figure 4.1.6- The Kataluwa coast of 1840 reveals that it had a huge protruded land mass. As shown by the topographical map of 1905-15, this land portion has been washed away and slight accumulation has been taken afterward(a). The Piyandigama coast (b) also occurred as a headland coast. The protruded land portion has been washed away during the period between 1840 and 1972.

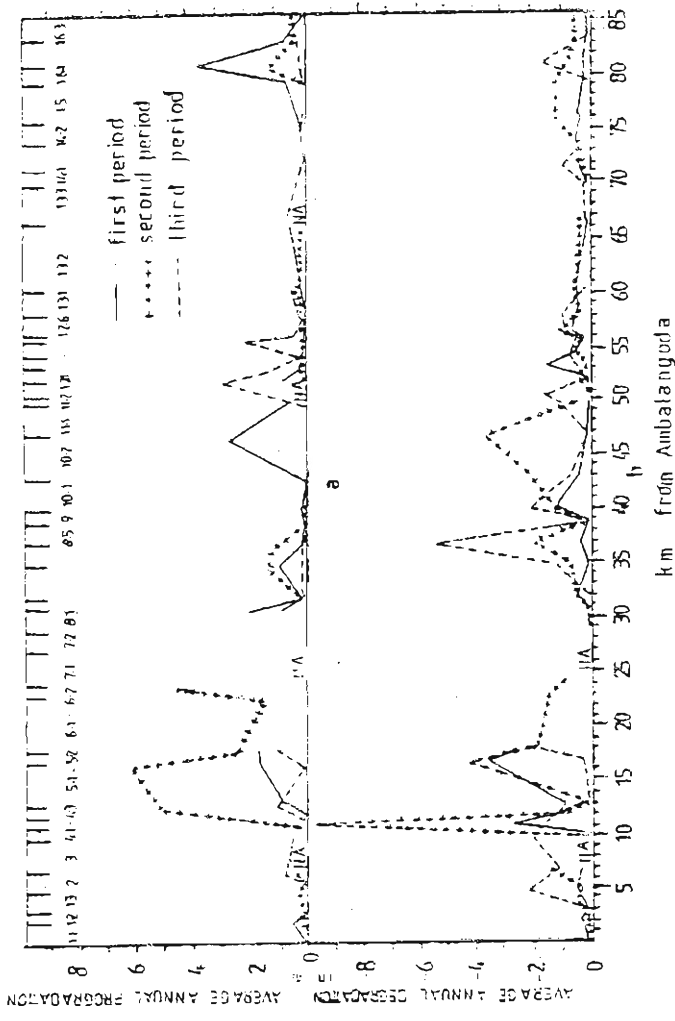
Figure 4.2.1- Average annual coastal degradation/progradation in the study area for the three periods distinguished during the 20 th century. The fluctuations in degradation and progradation indicate that the coastline was not characterized by continuous abrasion. (Average annual progradation/degradation for a period was obtained following the formula: $\frac{D_p}{Y_p} = Lc$, where D_p = degradation for the period progradation for the period, Y_p = years covered by the period, Lc = length of the coastal compartment. (The place names of the compartments appear in Table 4.2)

The data of the coastline changes reveal strong fluctuations in degradation and progradation during the 20 th century. The situation is summarized in Figure 4.2.1. The high progradation rates occurred along the coast from Narigama to the Gin River mouth (from 4.3 to 6.2) along the bay of Galle (8.1 to 8.5), the eastern and western sides of the Koggala outfall (10.2 to 11.2) and near the Nilwala River mouth (16.1, 16.2 and 16.3). All coastal compartments, however, exhibit changes during the 20 th century. The coasts NW of Galle have experienced total degradation during the first, second and third periods. Considerable progradation took place along the coasts only during the second period. The coasts SE of Galle have, except for a few segments (10.1, 10.2, 14.2 and 14.3), have been subjected to progradation at varying rates during the 20 th century. The progradation rate of the compartments near the Nilwala River mouth (16.1 and 16.2) exceeds degradation rates during the three periods. Figure 4.2.2 shows that in many compartments degradation exceeded progradation during the 20 th century. Considerable progradation only occurred along the coasts stretching from Waal island to Degalla (4.3 to 5.2), in some parts of the bay of Galle (8.1 and 8.2), Katukurunda-Piyandigama (10.2 to 12.2), in the bay of Weligama (13.2 to 13.3) and at the Nilwala River mouth (16.2).

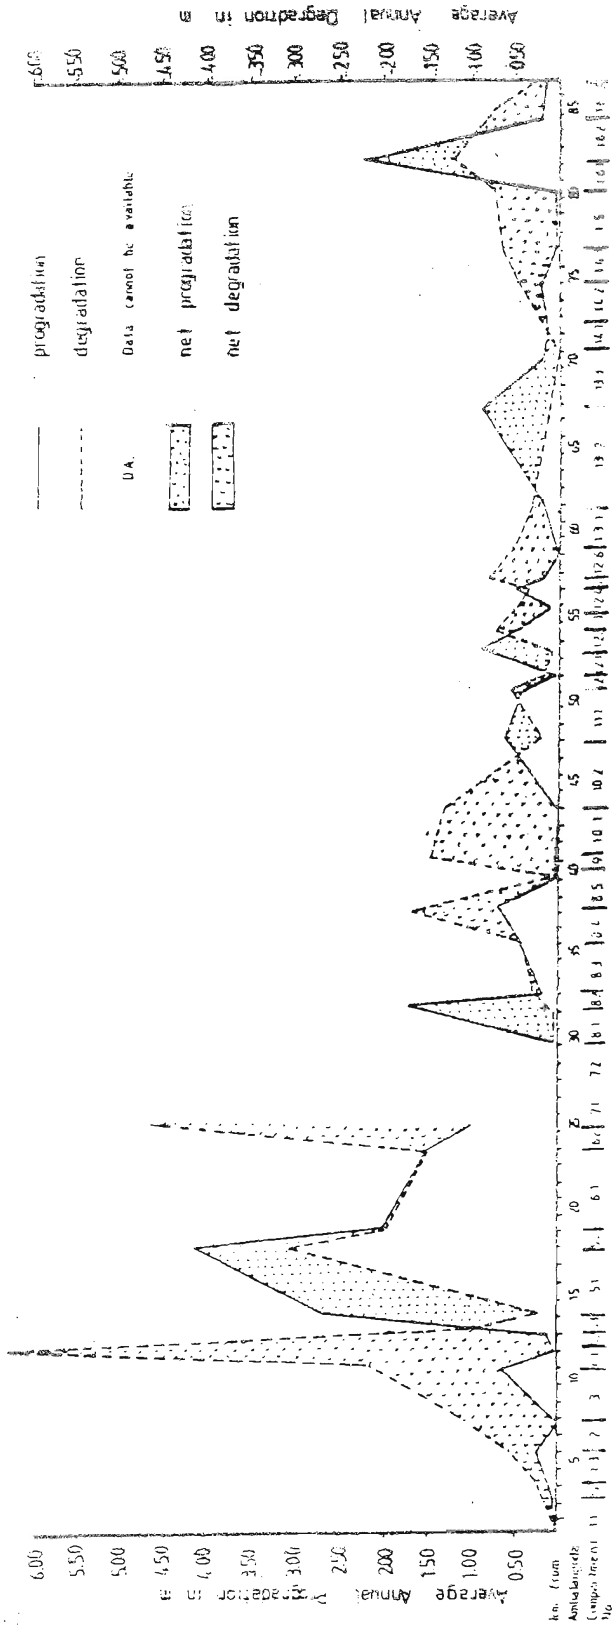
Figure 4.2.2- Average annual changes of the coastline of the Southwest during the 20th century. The differences between the progradation rates and degradation rates reveal the net degradation or progradation (The average values have been obtained by dividing the total of the degradation/progradation values by the years of observation and by the length of the compartment. The place names of the compartments appear in Table 4.2.
