Use of Façadism in Divided-Walled Nicosia, Cyprus

Christina Pieri

School of Architecture, Design & the Built Environment,
Nottingham Trent University, U.K.
christina.pieri2007@my.ntu.ac.uk

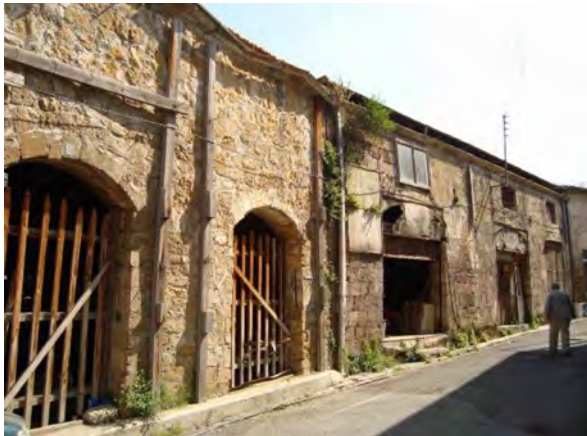
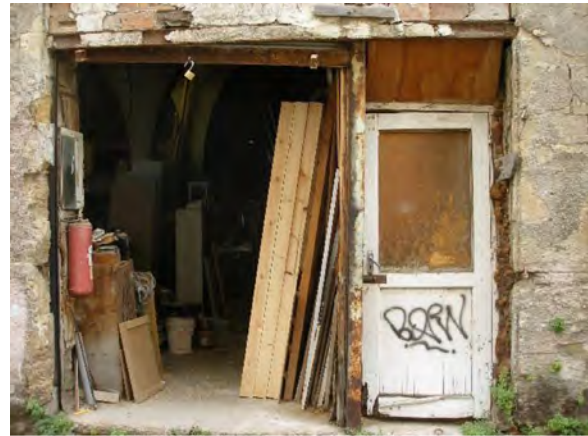
Figure 2: Dionisou Street before its rehabilitation by the NMP Source: Nicosia Master Plan office (2014a).

Figure 3: (bottom) Dionisou Street before its rehabilitation by the NMP Source: Nicosia Master Plan office (2014a).

A prominent example that demonstrates this approach is the one of Dionisou Street. This area primarily consists of workshops and residential buildings. Nevertheless, its proximity to the buffer zone, along with the gradual departure of long-term tenants from the area had resulted in the decay of its authentic fabric and vocational character.

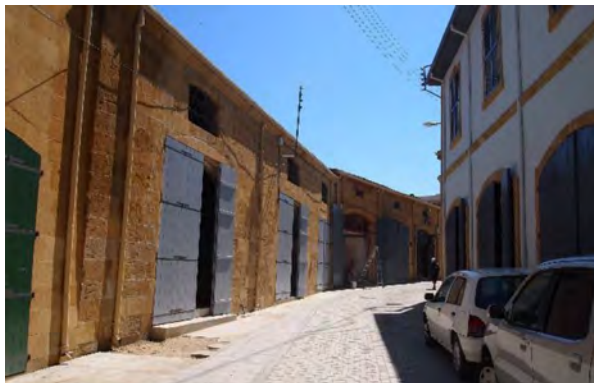
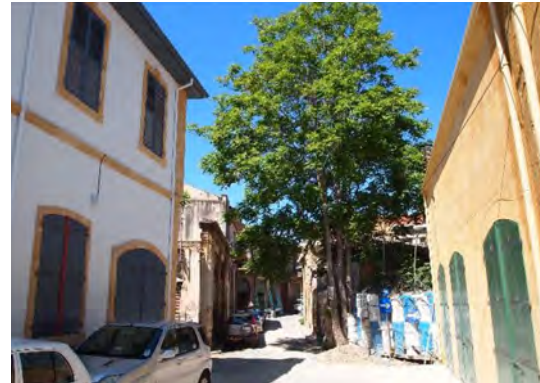
Figure 4: Restored facades at Dionisou street Source: Nicosia Master Plan Office (2014b)

Figure 5: Restored facades at Dionisou street Source: Nicosia Master Plan Office (2014b)

Following its restoration, and despite the fact that the functionality of the area has not been completely reinstated, the NMP's goal of 'gluing' the historic city back together has visibly altered the appearance of the specific street. Nonetheless, even though the buildings have been made structurally safe before being restored, the NMP's focus was on the aesthetic upgrading of buildings, primarily through façade restorations, rather than repairing their entire structures.

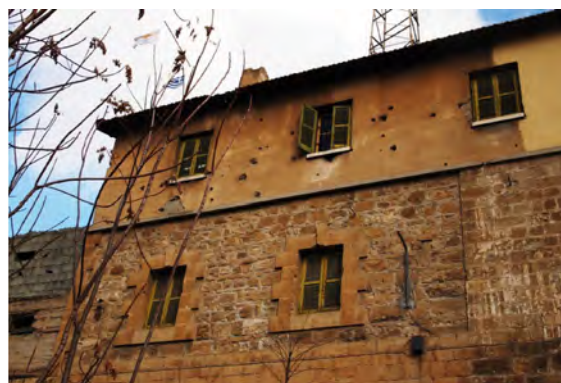
Figure 7: Governmental building (police station) next to the vehicular access and above the pedestrian access of Paphos gate. As can be observed, attempts to paint the façade (see right of picture) have been made. However, all regeneration attempts avoid the concealment of the existing bullet markings. Source: Author (2014).

An example that highlights this finding is that of the Paphos Gate area , where bullet holes and other conflict-related damage on the fabric of buildings over the walls has been preserved, despite restoration initiatives on the adjacent buildings (Figure 7 - Figure 9).

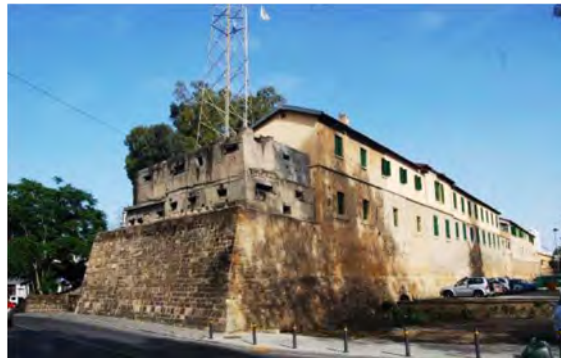
Figure 8: Vehicular access to walled Nicosia from the Paphos Gate Source: Unknown (2016).

The illustrated area of Paphos Gate is of particular tangible and intangible heritage significance to the Greek Cypriot and Turkish Cypriot communities of Cyprus, as it is one of the first and main access points to the walled city associated with commerce, surveillance and religious activities within the walls (Oswald, 2013). More specifically, Paphos Gate is one of the main entrances to the walled city that includes Venetian, Ottoman and British colonial buildings. The gate has always been a strategic position since the Ottoman and British times, and continues to function as a surveillance point under the Greek Cypriot Government, with the existence of a police station just above the pedestrian part of the gate (Figure 8). In addition, the area is associated with inter-communal riots commencing during the EOKA struggle and the Greek Cypriot - Turkish Cypriot struggle, “[which] resulted in the security forces erecting a barbed-wire fence along Paphos and Hermes Streets from the Paphos Gate to the Famagusta Gate” (Oswald, 2013). As a result, the memories associated with the Gate go beyond the tangible built environment and recall significant aspects of the Greek Cypriot - Turkish Cypriot conflict.

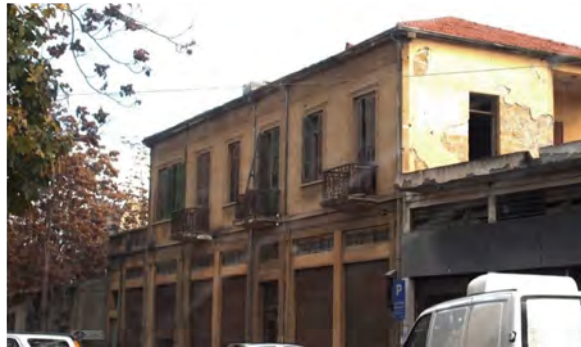
Figure 10: Façades on Paphos Street before restoration, walled Nicosia

Figure 10 and Figure 11 demonstrate that on Paphos Street, buildings next to the buffer zone have been restored following a similar approach to that used on Dionisou Street. In both cases, the use of façadeism is visible as a key strategy for the beautification of decaying buildings and neighbourhoods. However, the example of Paphos Gate suggests of a disparity between the treatment of the buffer zone boundary, when compared to parts of the Venetian walls that have been influenced by conflict. The management of heritage in this case, differs from one area to the other, with traces of conflict being selectively preserved throughout the walled city. This phenomenon is mainly visible in the south-west part of Nicosia and closer to the buffer zone area; due to the increased number of projects undertaken by the NMP in the Greek Cypriot part of the walls.

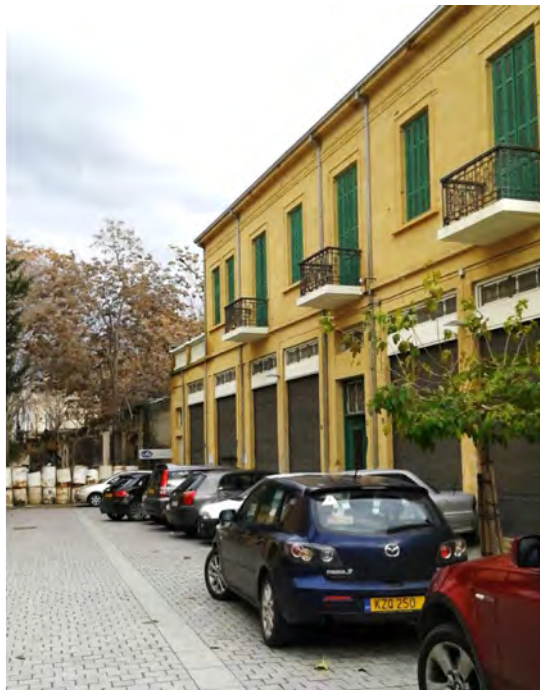
Figure 11: Recently restored building facades on Paphos Street, walled Nicosia Source: Author (2017).

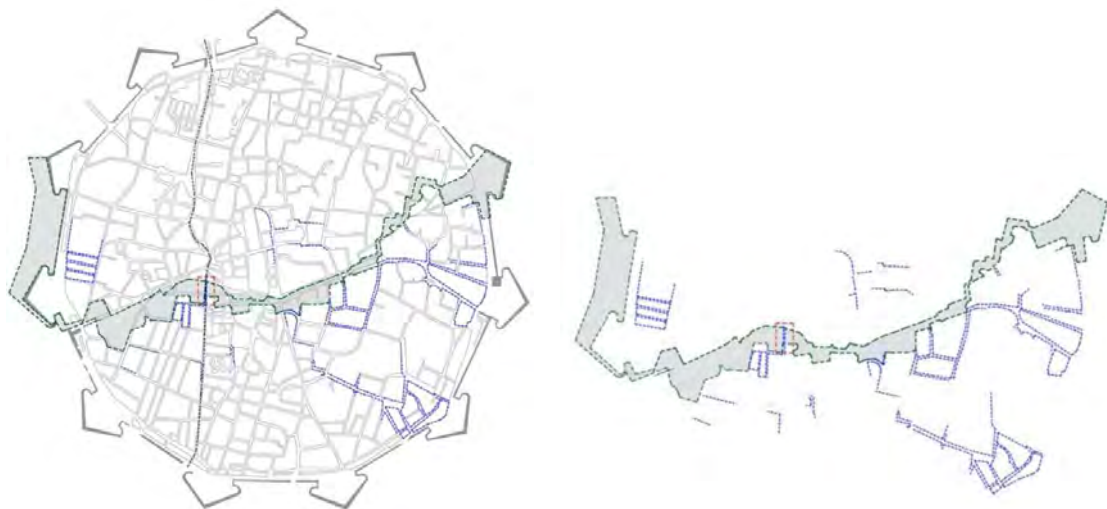
Figure 12: Figure illustrating the use of façadeism throughout the walled city of Nicosia. As can be observed, funding availability for the South Nicosia Municipality - and NMP team - has encouraged the increased implementation of this approach at different locations within the walls, including areas close to the buffer zone. Source: Author (2017).

Lastly, the examination of the walled city of Nicosia indicates that the use of façadeism has been more vividly employed in the south part of the walled city (Figure 12), which has significantly contributed to the beautification of buildings and neighbourhoods. However, the fact that the practice of façadeism is uniform throughout the historic core raises questions about the individual assessment of the building stock and the understanding of their unique characteristics and historical significance. The following figure illustrates the use of façadeism throughout the walled city of Nicosia. As can be observed from Figure 12, a significant amount of façade restoration has been established, particularly in the south part of the walls. The image is informed by the fieldwork findings of the author as well as the information provided by the NMP, and excludes complete building restorations.
